INVESTIGATION OF PLANE-STRAIN FLAW GROWTH IN THICK-WALLED TANKS

Contract NAS3-4194

Aerospace Group
THE BOEING COMPANY
Seattle, Washington

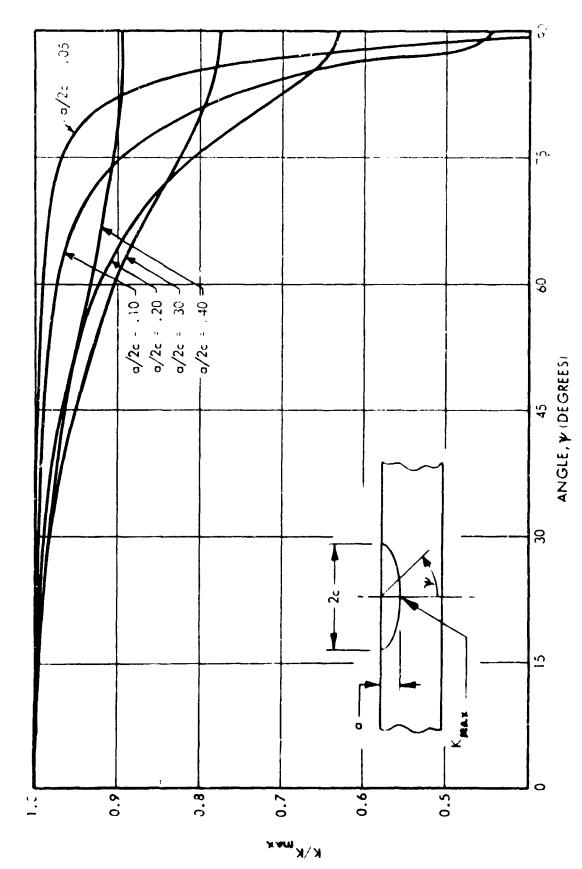
Figure 1: VARIATION OF STRESS INTENSITY ALONG FLAW PERIPHERY

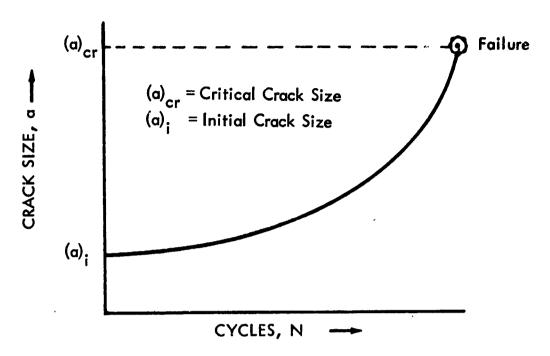
Figure 2a: BASIC CRACK GROWTH CURVE Schematic Representation

For through-the-thickness cracks growing under conditions of plane stress, a versus N curves can be generated by cycling center-cracked fracture specimens under given loading conditions. Periodic measurements of crack length are made after given numbers of load applications. A typical, a versus N curve generated by means of the above method is schematically illustrated in Figure 2a.

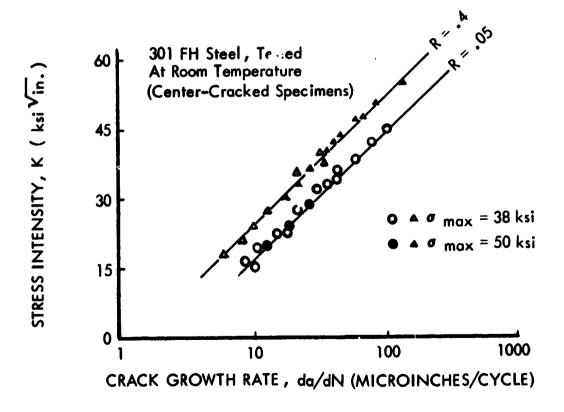
Figure 2b: CRACK GROWTH-RATE DATA Actual Sample

Plane stress crack growth tests (Refs. 11 and 12) have shown that the crack growth rate for a given material is dependent primarily on the maximum stress intensity (K_{max}) and on the ratio of minimum stress intensity to maximum stress intensity, R. The growth rates are influenced to a lesser extent by cyclic speed and test temperature. A typical da/dN versus K_{max} curve is illustrated in Figure 2b for two different R values.

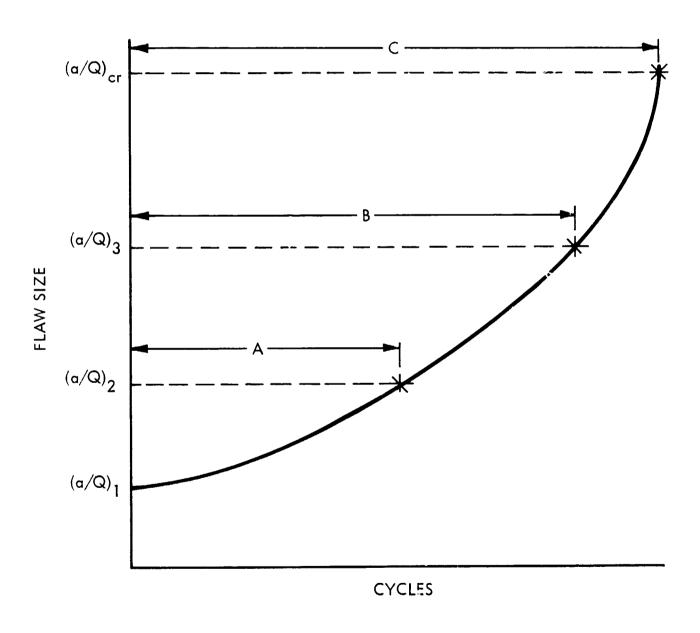
Figure 3: FLAW-GROWTH MEASUREMENT FROM A SINGLE SPECIMEN

Cyclic life data can be plotted in a number of ways. For instance, the data of Figure 3 can be plotted in terms of initial flaw size versus the corresponding cycles to failure as schematically illustrated in Figure 4a. The maximum stress intensities for the initial flaw can also be plotted against the corresponding cycles to failure as as schematically illustrated in Figure 4b.

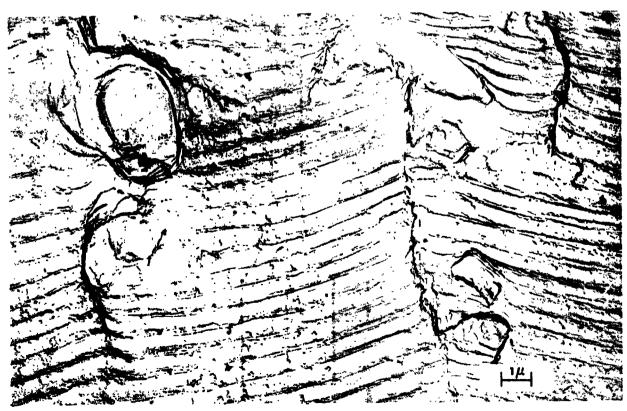
Figure 8b: ELECTRON MICROGRAPH OF CYCLIC CRACK GROWTH IN 7075-T6 ALUMINUM

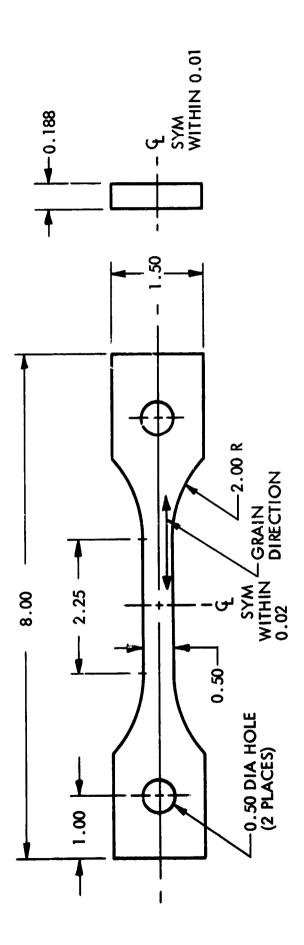
Figure 9: TENSILE SPECIMEN (TITANIUM)

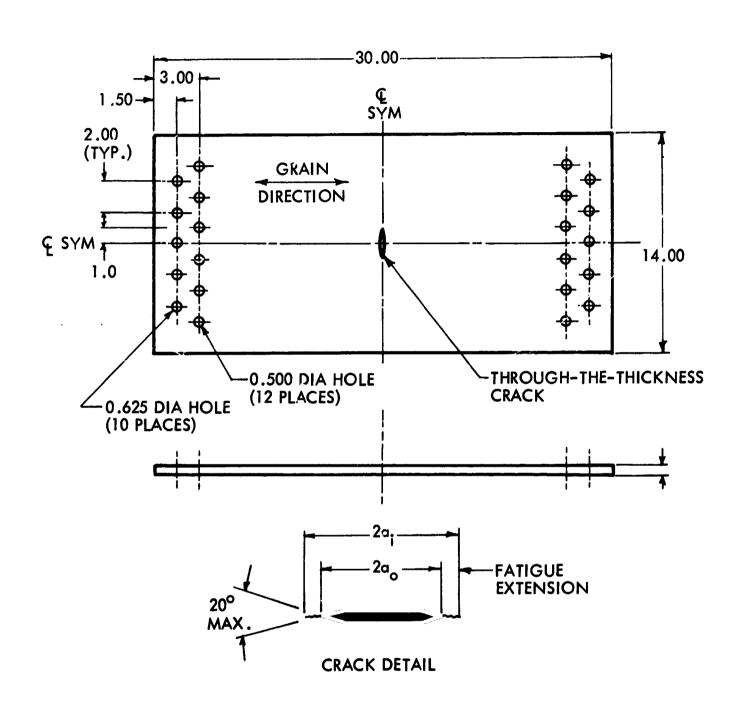
Figure 10: THROUGH-THE-THICKNESS CENTRALLY CRACKED FRACTURE TOUGHNESS SPECIMEN

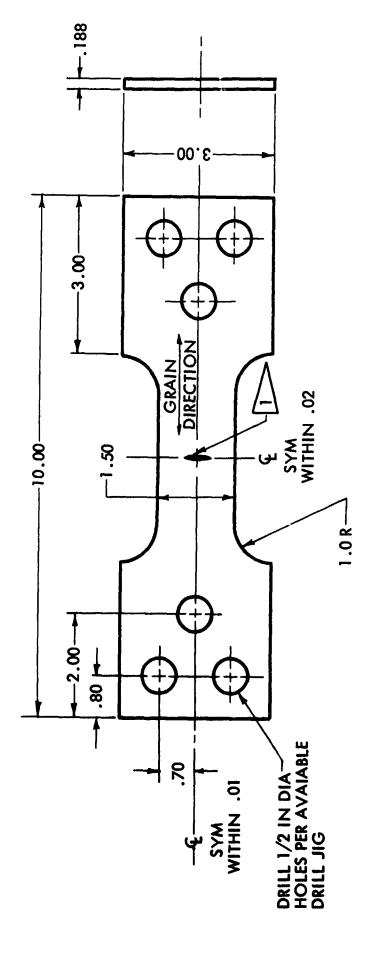
MADE BY ELECTRICAL DISCHARGE
MACHINE AND LOW-STRESS FATIGUE

Figure 11: SURFACE-FLAWED TITANIUM SPECIMEN

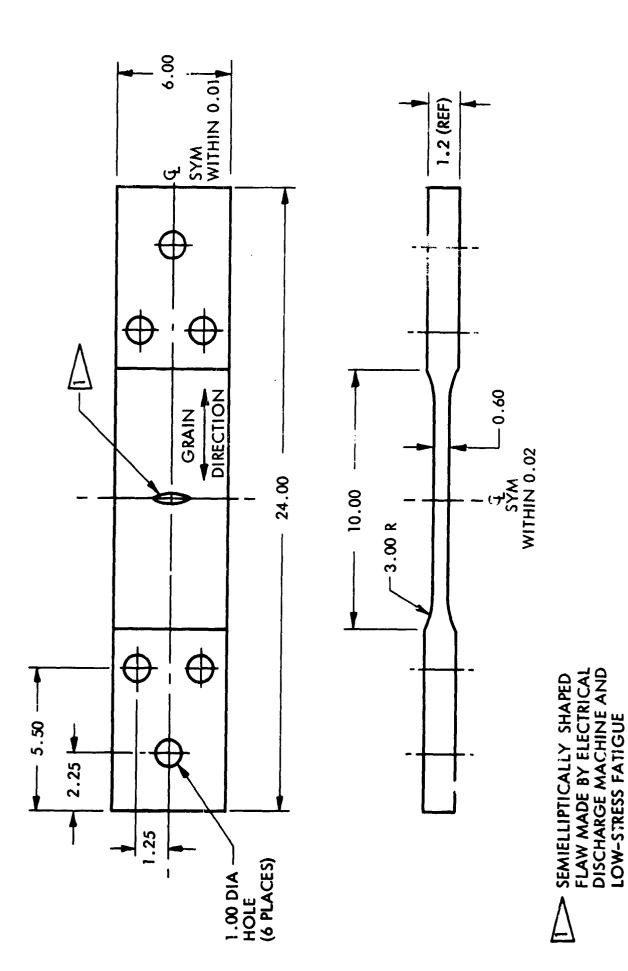
SURFACE-FLAWED SPECIMEN FOR 0.6 IN. ALUMINUM Figure 14:

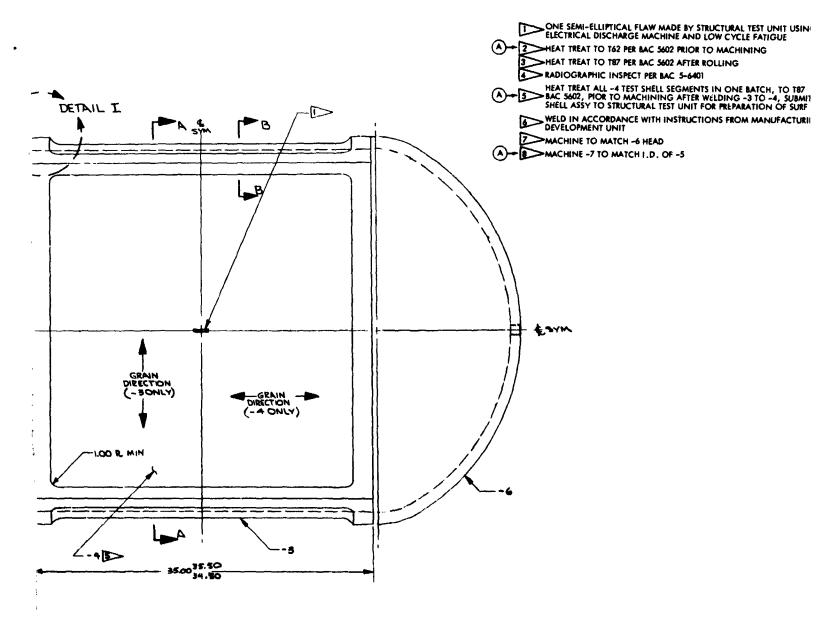
29-40745-1 TEST TANK ASSY Figure 17: 2219-T87 ALUMINUM TEST TANK ROOM TEMP. AND -3200F TEST I

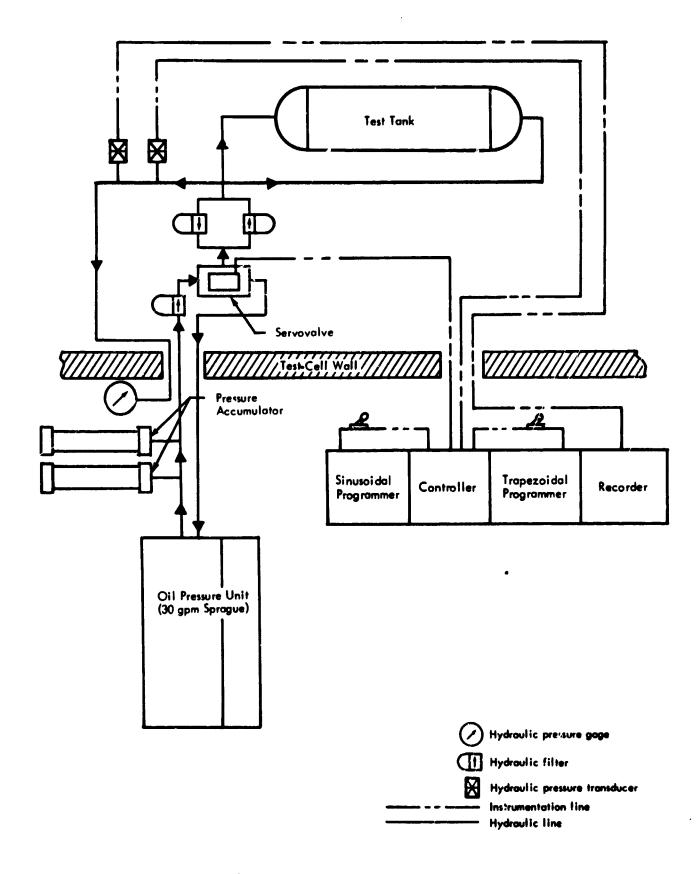
Figure 22: SCHEMATIC DIAGRAM OF PRESSURE AND CONTROL SYSTEM USED FOR ROOM TEMP TANK TESTS

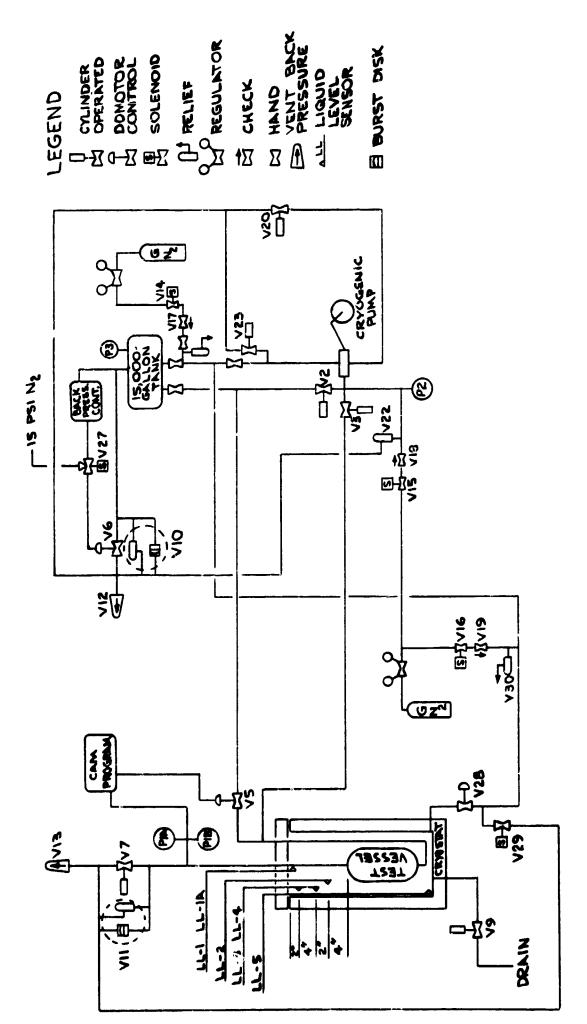
SCHEMATIC DIAGRAM OF PRESSURE AND CONTROL SYSTEM USED FOR -320°F TANK TESTS Figure 23:

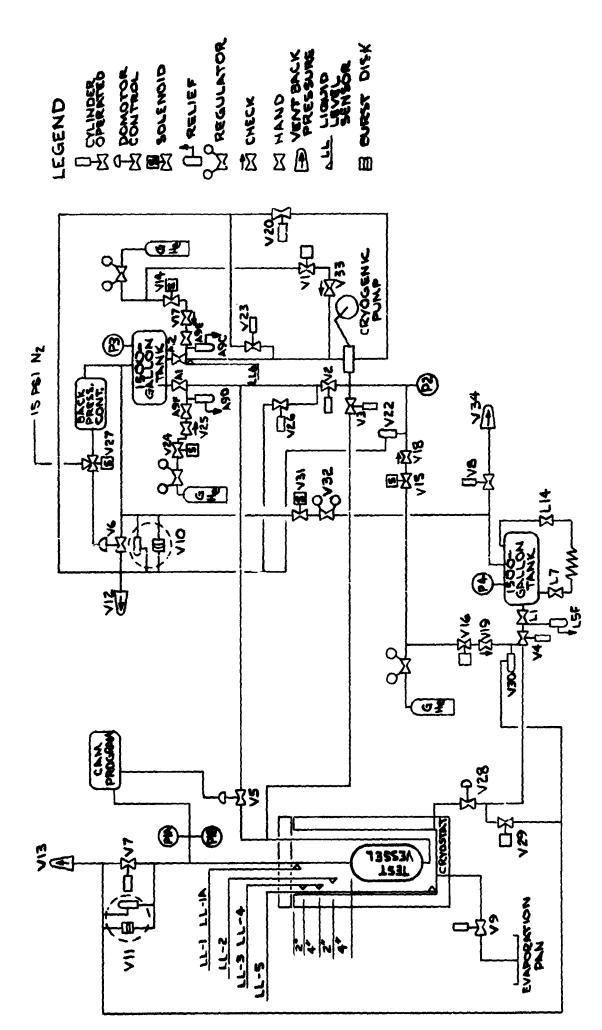
Figure 24: SCHEMATIC DIAGRAM OF PRESSURE AND CONTROL SYSTEM USED FOR -423°F TEST TANKS

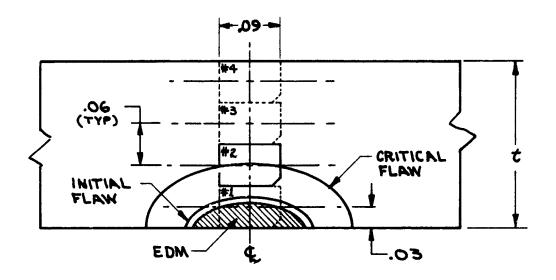
Figure 28a: SCHEMATIC ILLUSTRATION OF GRID AND REPLICA LOCATION ON FRACTURE FACE OF TEST SPECIMEN

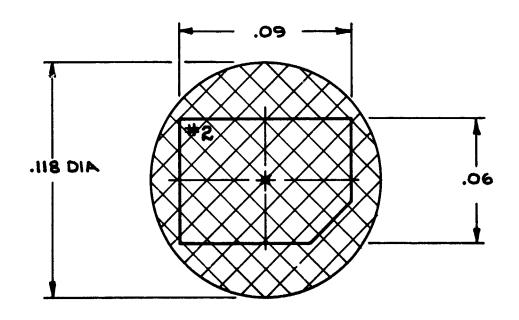
Figure 28b: SCHEMATIC ILLUSTRATION OF SAMPLE GRID WITH TYPICAL REPLICA

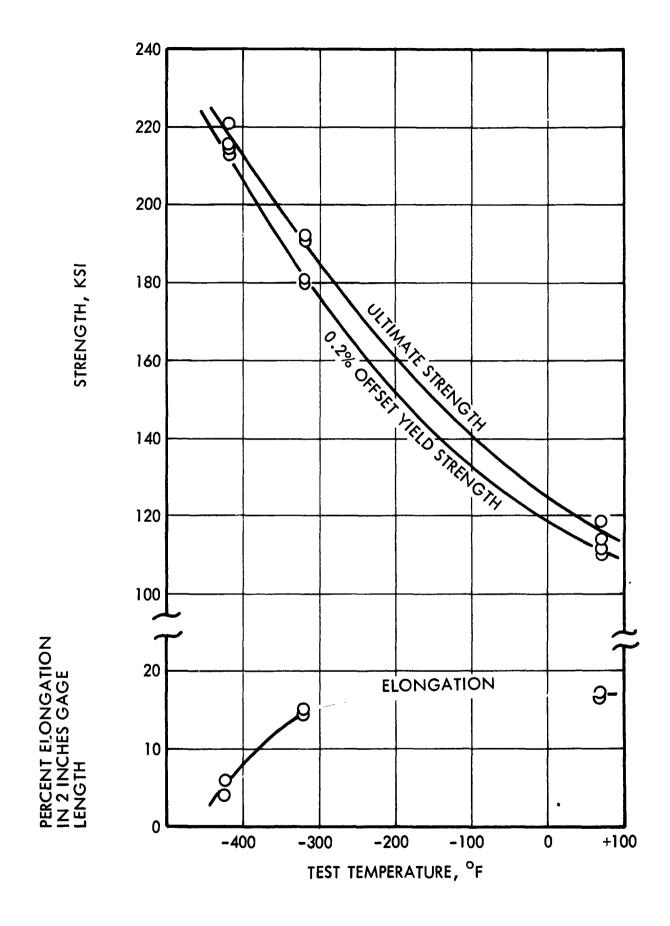
Figure 29: MECHANICAL PROPERTIES OF 5A1-2.5 Sn (ELI) TITANIUM PLATE

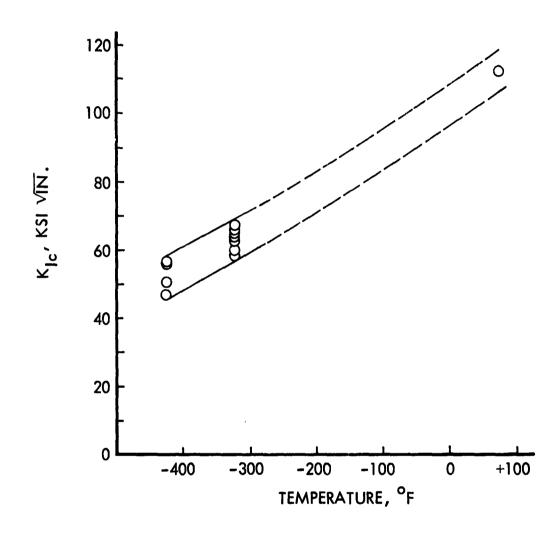
Figure 31: PLANE STRAIN FRACTURE TOUGHNESS OF 5A1-2. 5 Sn (ELI) TITANIUM

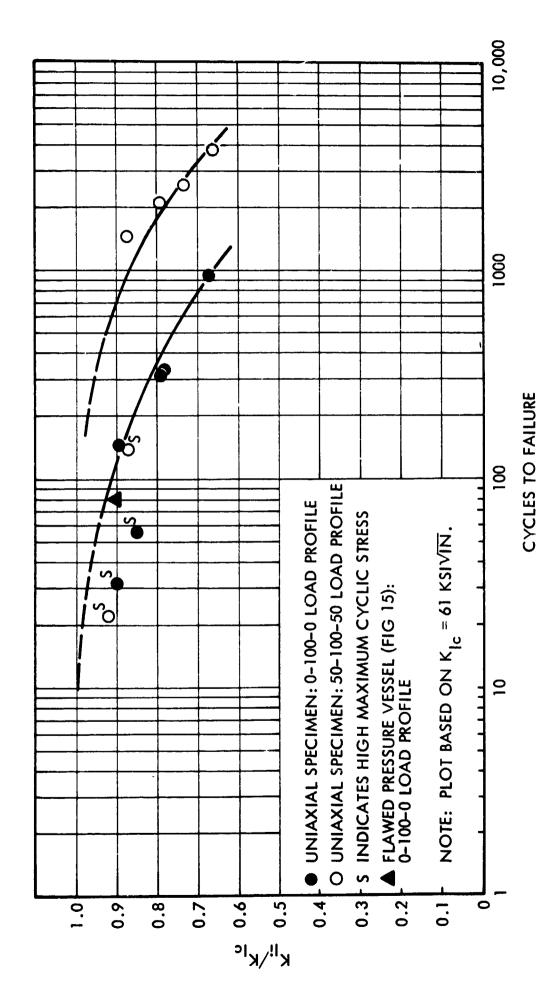
STRESS INTENSITY VS CYCLES-TO-FAILURE CORRELATION FOR 5AI -2.5 Sn (ELI) TITANIUM AT -320°F Figure 33:

The cyclic life data in Figures 33 and 34 can also be represented on σ versus a/Q plots. This has been done in Figures 35 through 38. Constant-cycles-to-failure curves were plotted to represent the average K_{Ii} versus N curves in Figures 33 and 34.

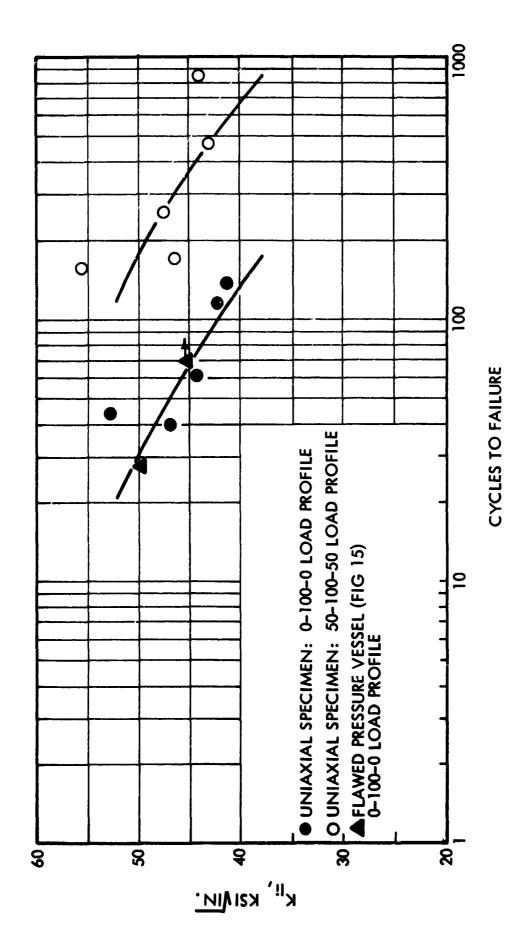
STRESS INTENSITY VS CYCLES-TO-FAILURE CORRELATION FOR 5AI -2.5 Sn (ELI) TITANIUM AT-423°F Figure 34:

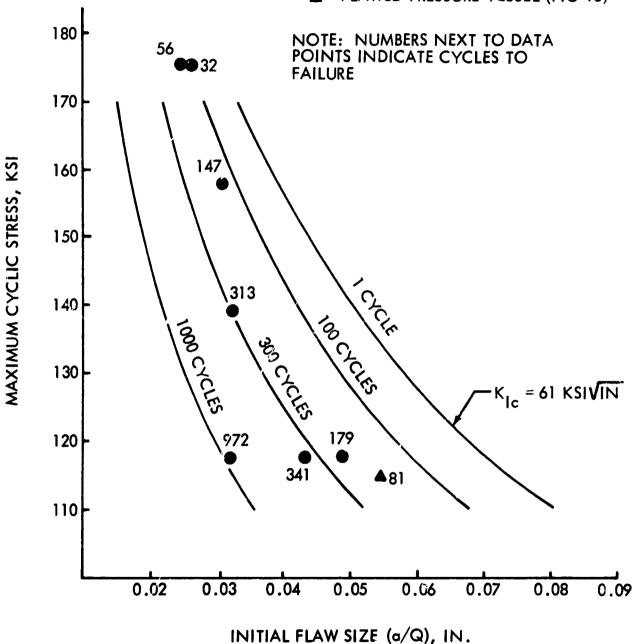
Figure 35: CYCLIC FLAW GROWTH DATA FOR 5A1 -2.5 Sn (ELI) TITANIUM AT -320°F (0-100-0 LOAD PROFILE)

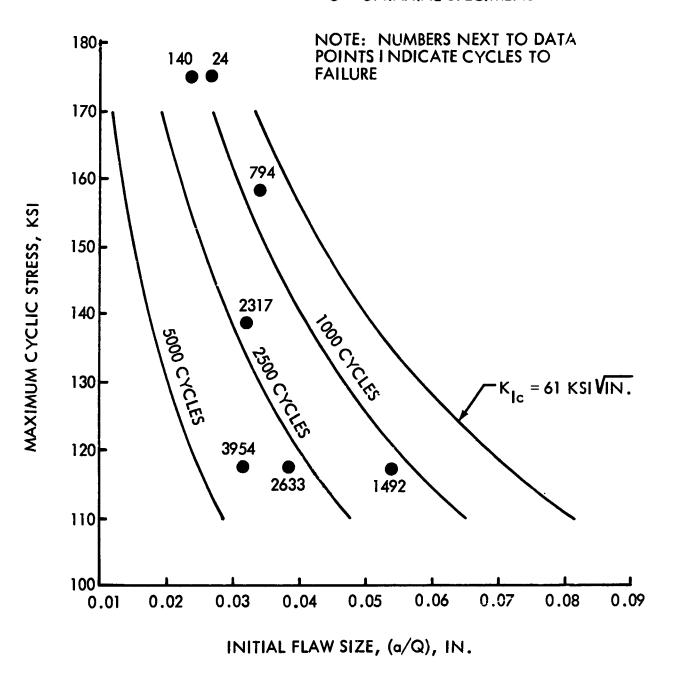
Figure 36: CYCLIC FLAW GROWTH DATA FOR 5A1 -2.5 Sn (ELI)
TITANIUM AT -320°F (50-100-50 LOAD PROFILE)

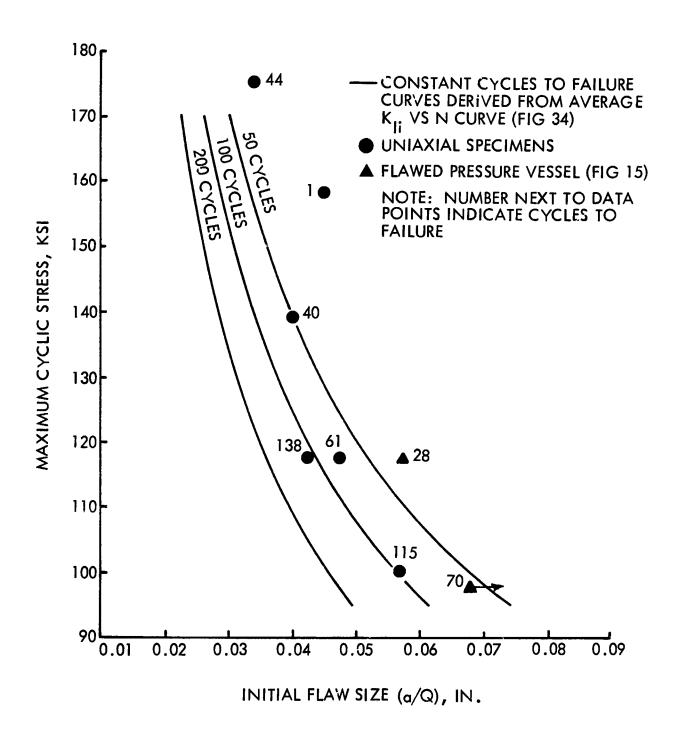
Figure 37: CYCLIC FLAW GROWTH DATA FOR 5A1 -2.5 Sn (ELI) TITANIUM AT -423⁰F (0-100-0 LOAD PROFILE)

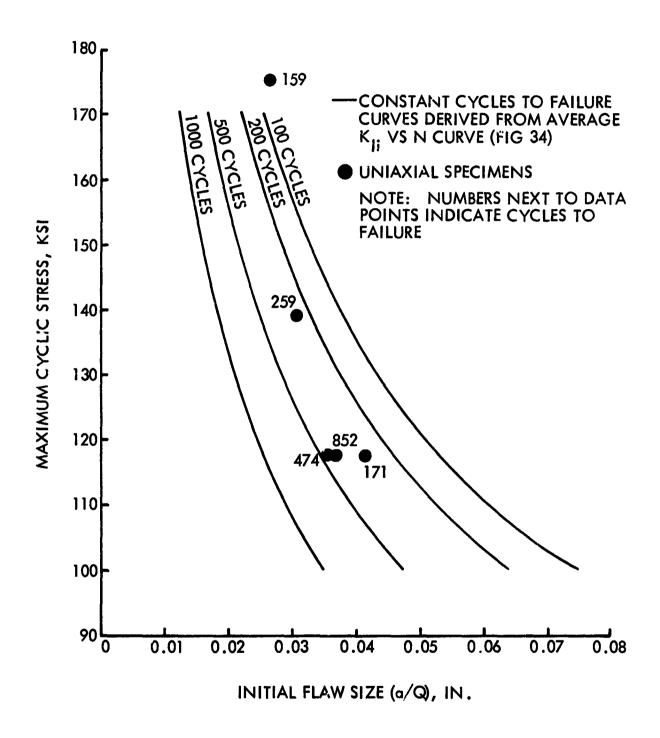
Figure 38: CYCLIC FLAW GROWTH DATA FOR 5A1 -2.5 Sn (ELI) TITANIUM AT -423°F (50-100-50 LOAD PROFILE)

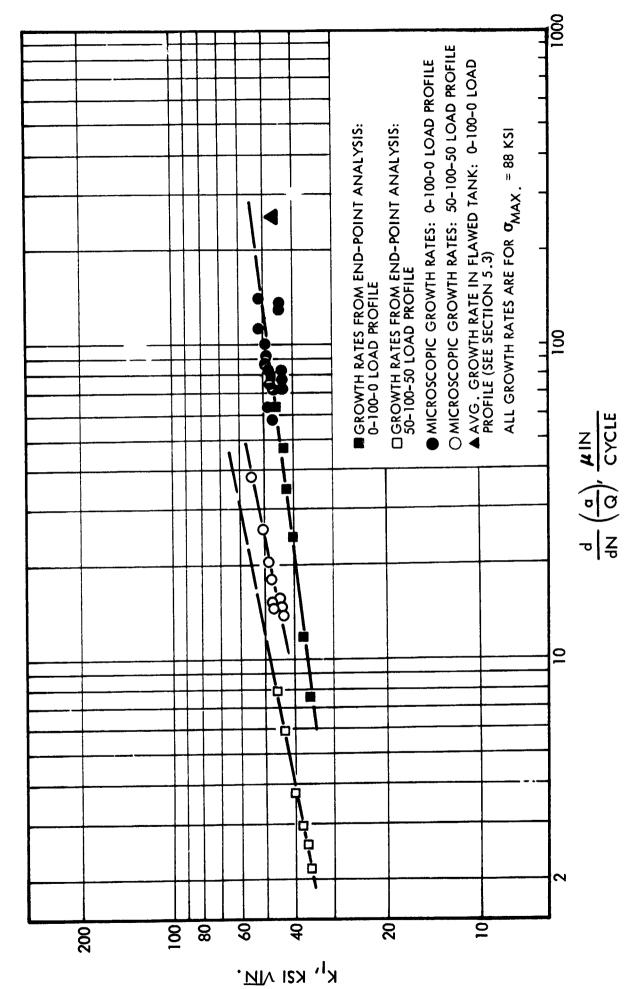
FLAW GROWTH RATES FOR 5A1 -2.5 Sn (ELI) TITANIUM AT ROOM TEMPERATURE

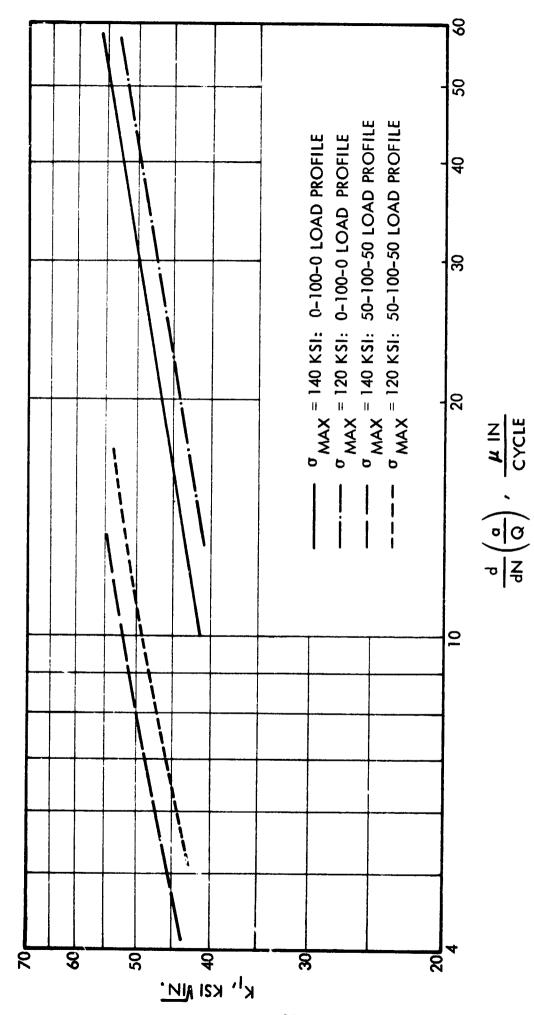
FLAW GROWTH RATES COMPUTED FROM END POINT ANALYSES FOR 5AI -2.5 Sn (ELI) TITANIUM AT -320°F Figure 40:

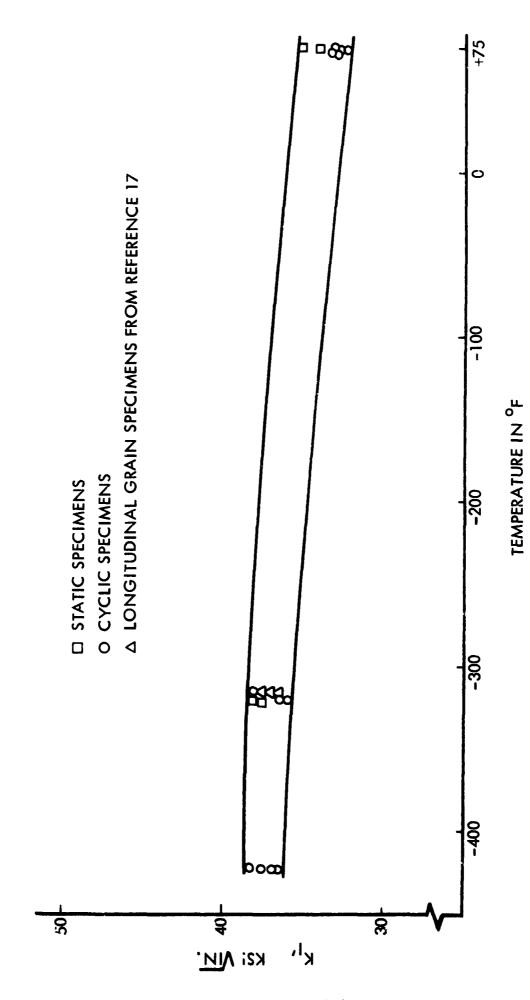
PLANE STRAIN FRACTURE TOUGHNESS OF 2219-T87 ALUMINUM (LONG TRANSVERSE GRAIN AS A FUNCTION OF TEMPERATURE) Figure 52:

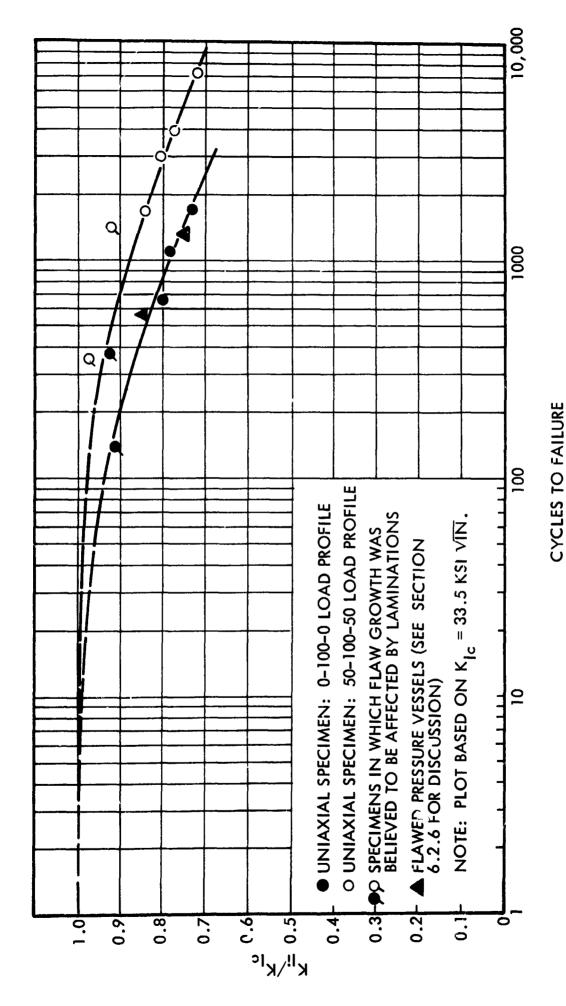
STRESS INTENSITY VS CYCLES TO FAILURE CORRELATION FOR 2219-T87 ALUMINUM AT ROOM TEMPERATURE Figure 53:

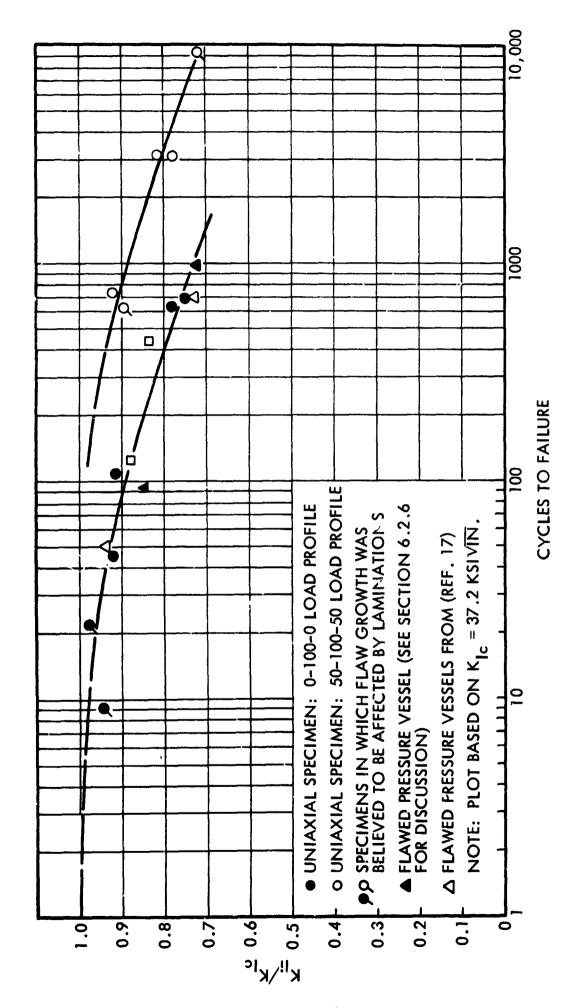
STRESS INTENSITY VS CYCLES TO FAILURE CORRELATION FOR 2219-T87 ALUMINUM AT -320°F Figure 54:

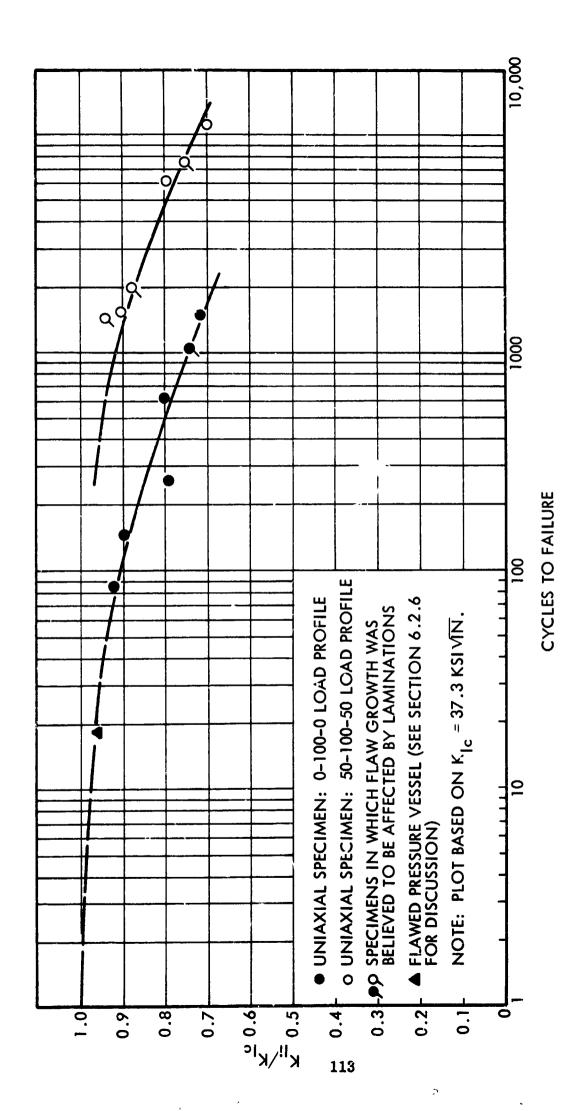
STRESS INTENSITY VS CYCLES-TO-FAILURE CORRELATION FOR 2219-T87 ALUMINUM AT -423°F Figure 55:

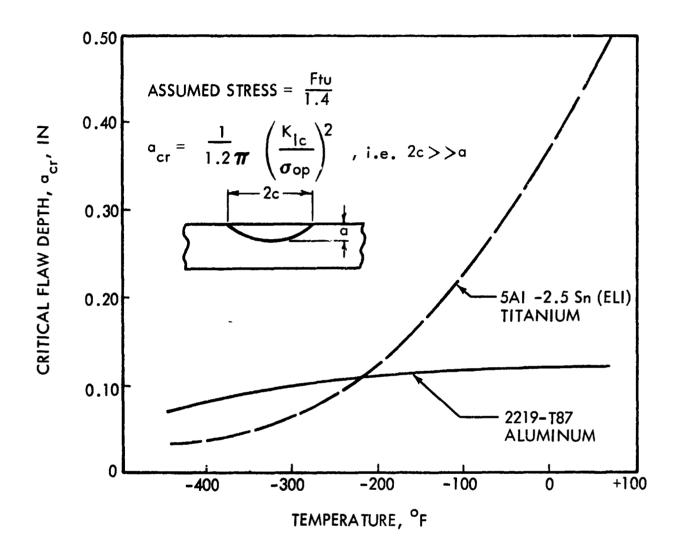
Figure 76: CRITICAL FLAW SIZES AT OPERATING STRESS FOR 5AI -2.5 Sn (ELI) TITANIUM AND 2219-T87 ALUMINUM VS TEMPERATURE

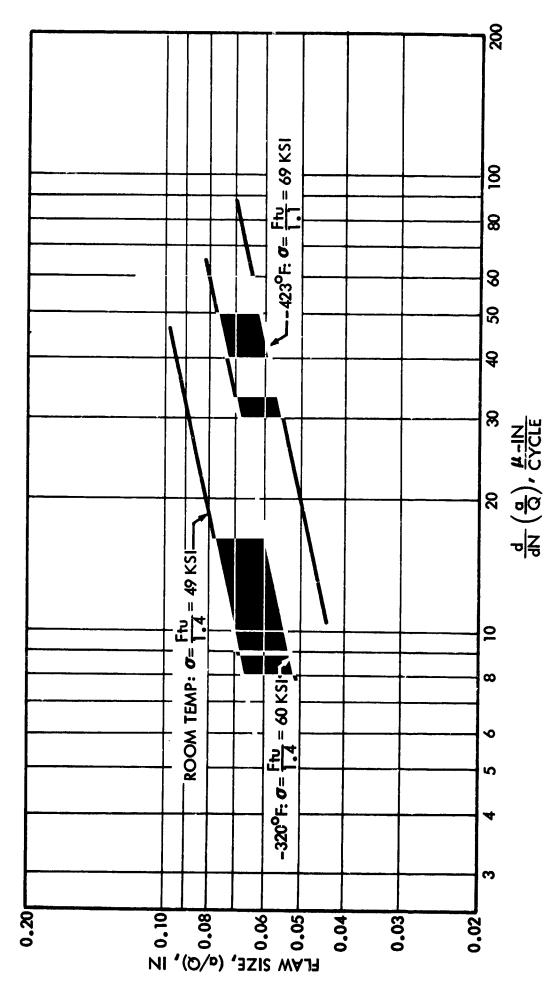
Figure 78: FLAW GROWTH RATES AT OPERATING STRESS VS. FLAW SIZE FOR 2219-T87 ALUMINUM (0-100-0 LOAD PROFILE)

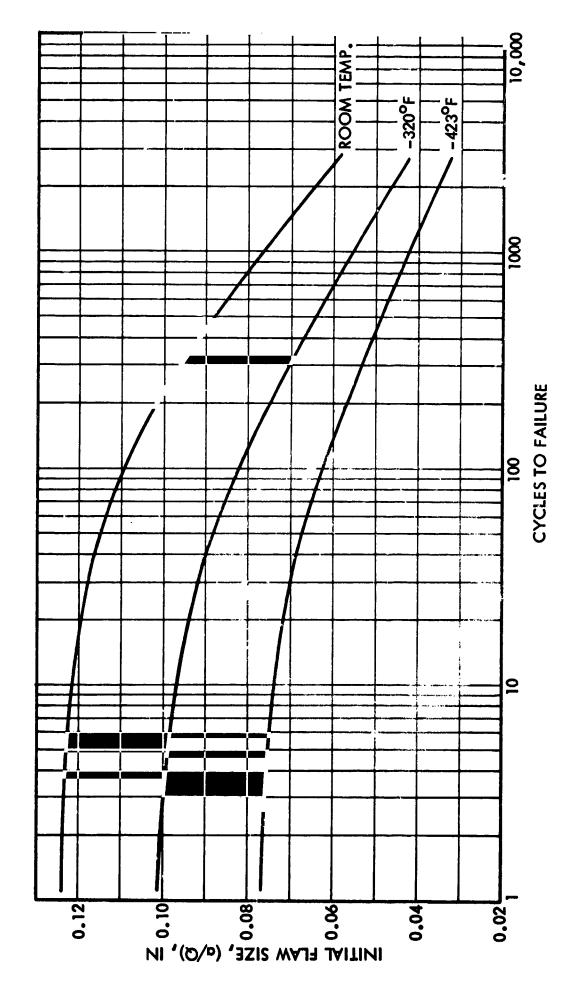
Figure 80: CYCLES TO FAILURE AT OPERATING STRESS VS. INITIAL FLAW SIZE FOR 2219-T87 ALUMINUM (0-100-0 LOAD PROFILE)

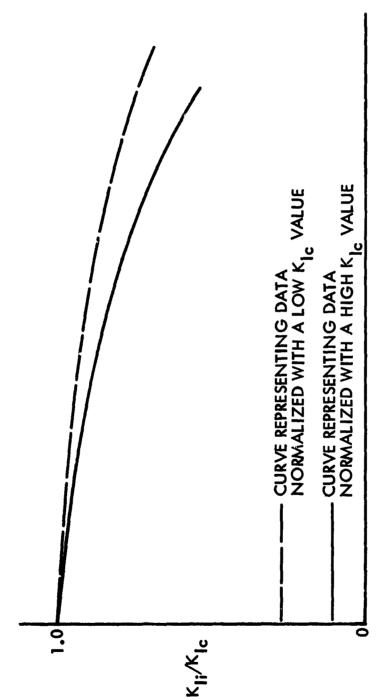
Figure A2: SCHEMATIC REPRESENTATION OF THE EFFECT OF KIC ON NORMALIZED CYCLIC-LIFE CURVES

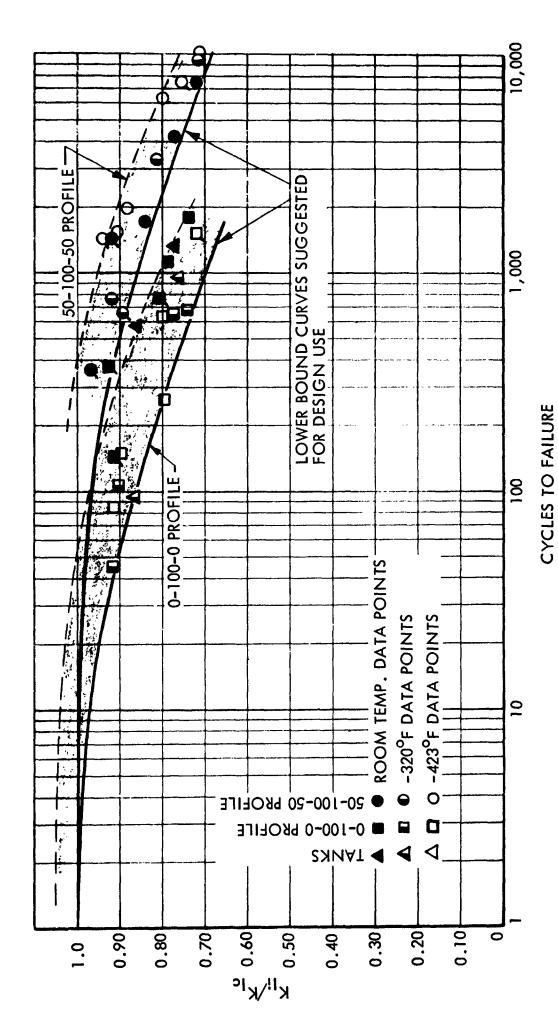
Figure A3: COMPOSITE CYCLIC FLAW GROWTH DATA 2219-T87 ALUMINUM @ ROOM TEMPERATURE, -320°F & -423°F

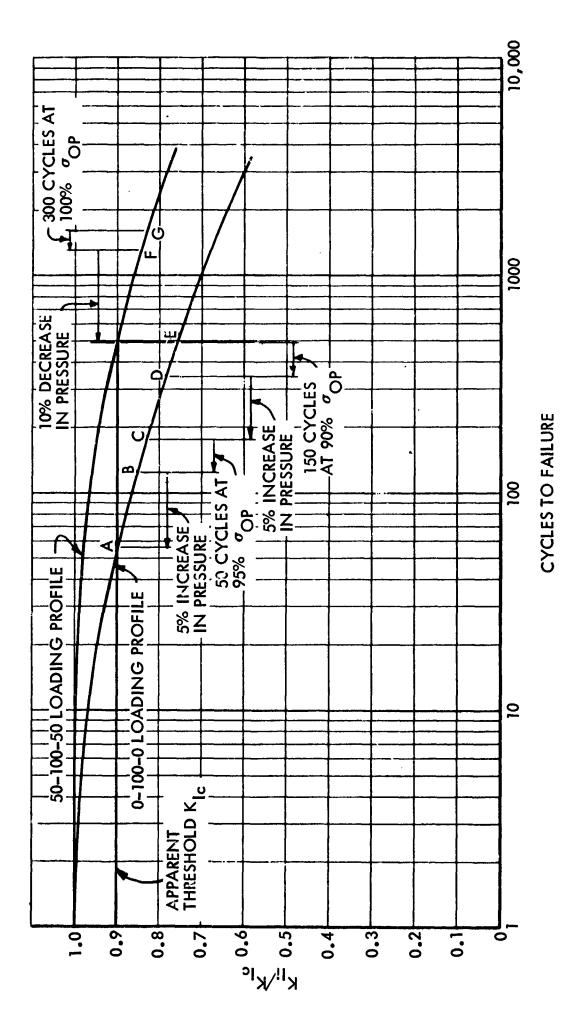
Figure A5: ILLUSTRATIVE DES IGN OF 2219-T87 ALUMINUM YANK

The titanium tank was the lighter of the two tanks. However, the allowable maximum flaw size at proof stress is only 0.018-inch (or only one third of the allowable maximum flaw size at proof stress for the aluminum tank). It would be very difficult to fabricate titanium tanks and ensure by nondestructive inspection that there were no flaws greater than 0.018 in. A number of titanium tanks could be expected to fail during proof test. The allowable flaw size in the aluminum tank is larger, and it would be easier to fabricate acceptable aluminum tanks than to fabricate acceptable titanium tanks.
